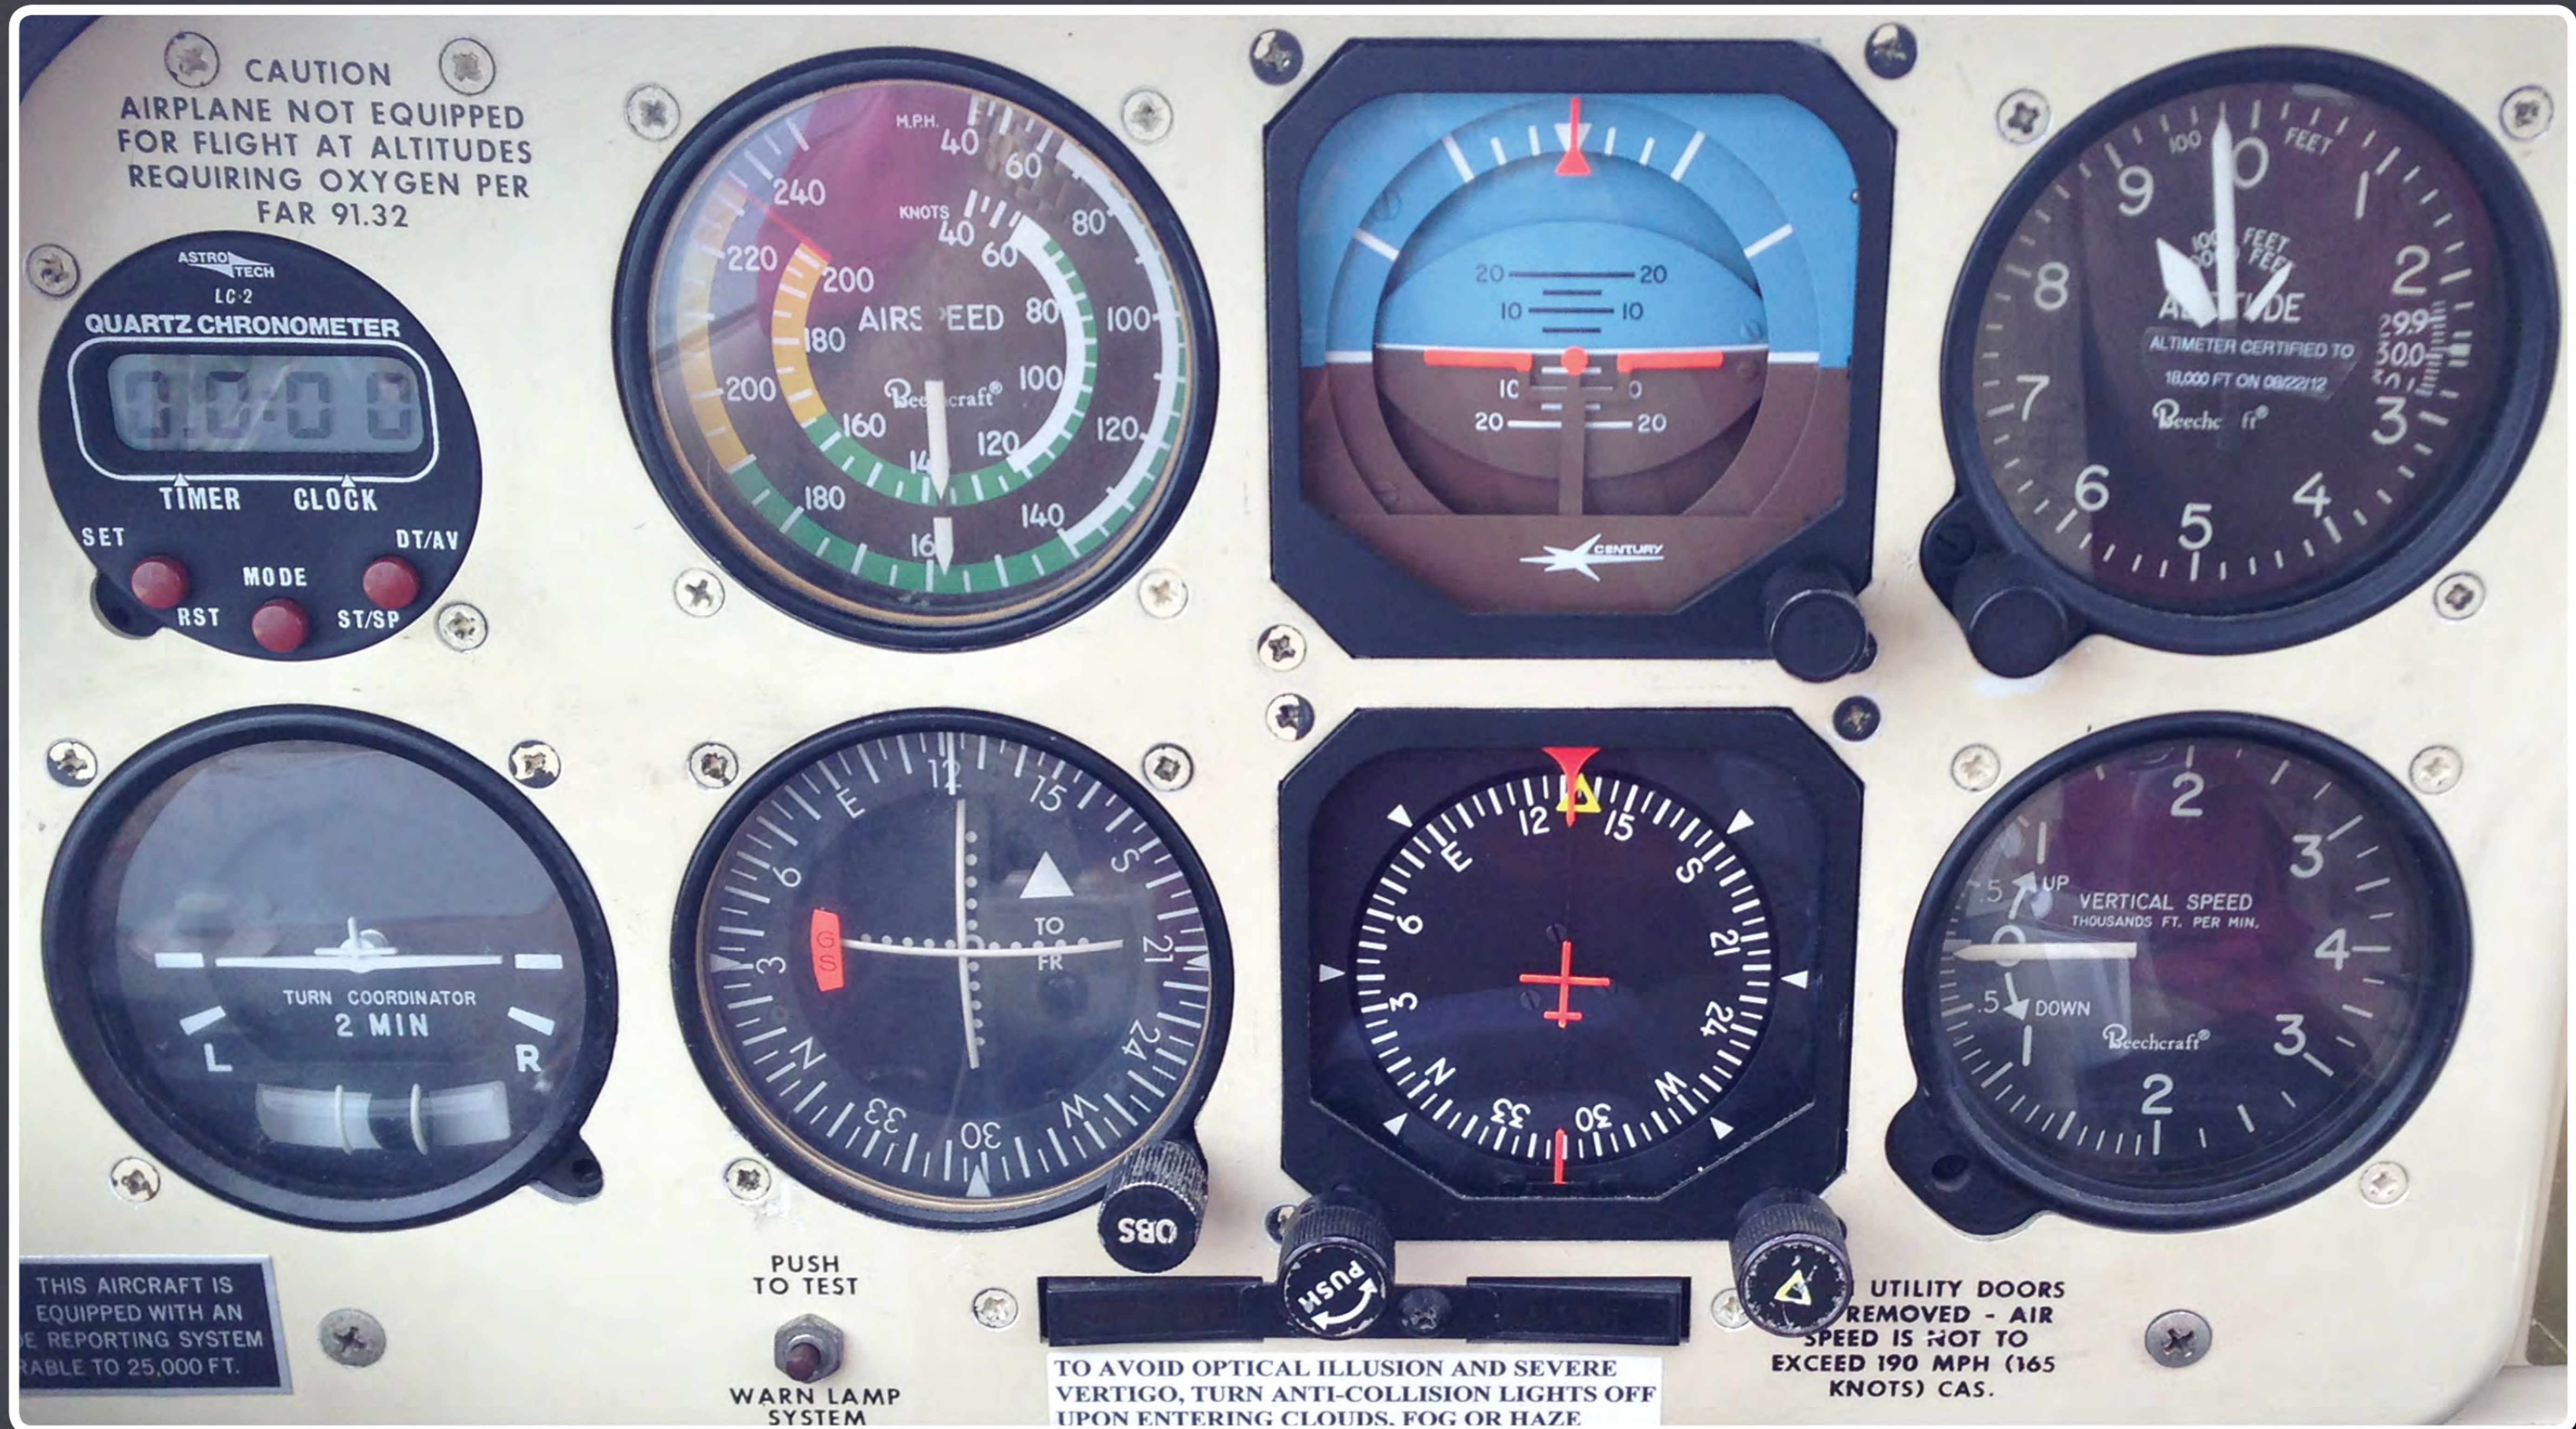
*What's wrong with the picture below? Okay, I'm about 20 feet below my assigned altitude (if I told you I was about to dial in an altimeter setting change, would you believe me?). No, look closer. I'll give you a hint—it's a required IFR flight instrument. You probably notice that the slip/skid indicator (née inclinometer's ball) shows a slight deflection. A little right rudder pressure to center the ball, then aileron trim to keep it there (the Beech Bonanza's aileron and rudder are interconnected, so adjusting aileron deflection also adjusts the rudder slightly—there's no separate rudder trim) and the indicated airspeed increased by three knots. This was about four knots of true airspeed increase, free, just by centering the ball with rudder and establishing coordinated flight.*
